GROUNDWATER SOURCE CONTROL INTERIM MEASURES DESIGN ANALYSIS, PLANS AND SPECIFICATIONS EAST HELENA FACILITY

Prepared for
ASARCO Incorporated
100 Smelter Road
East Helena, Montana

March 2000

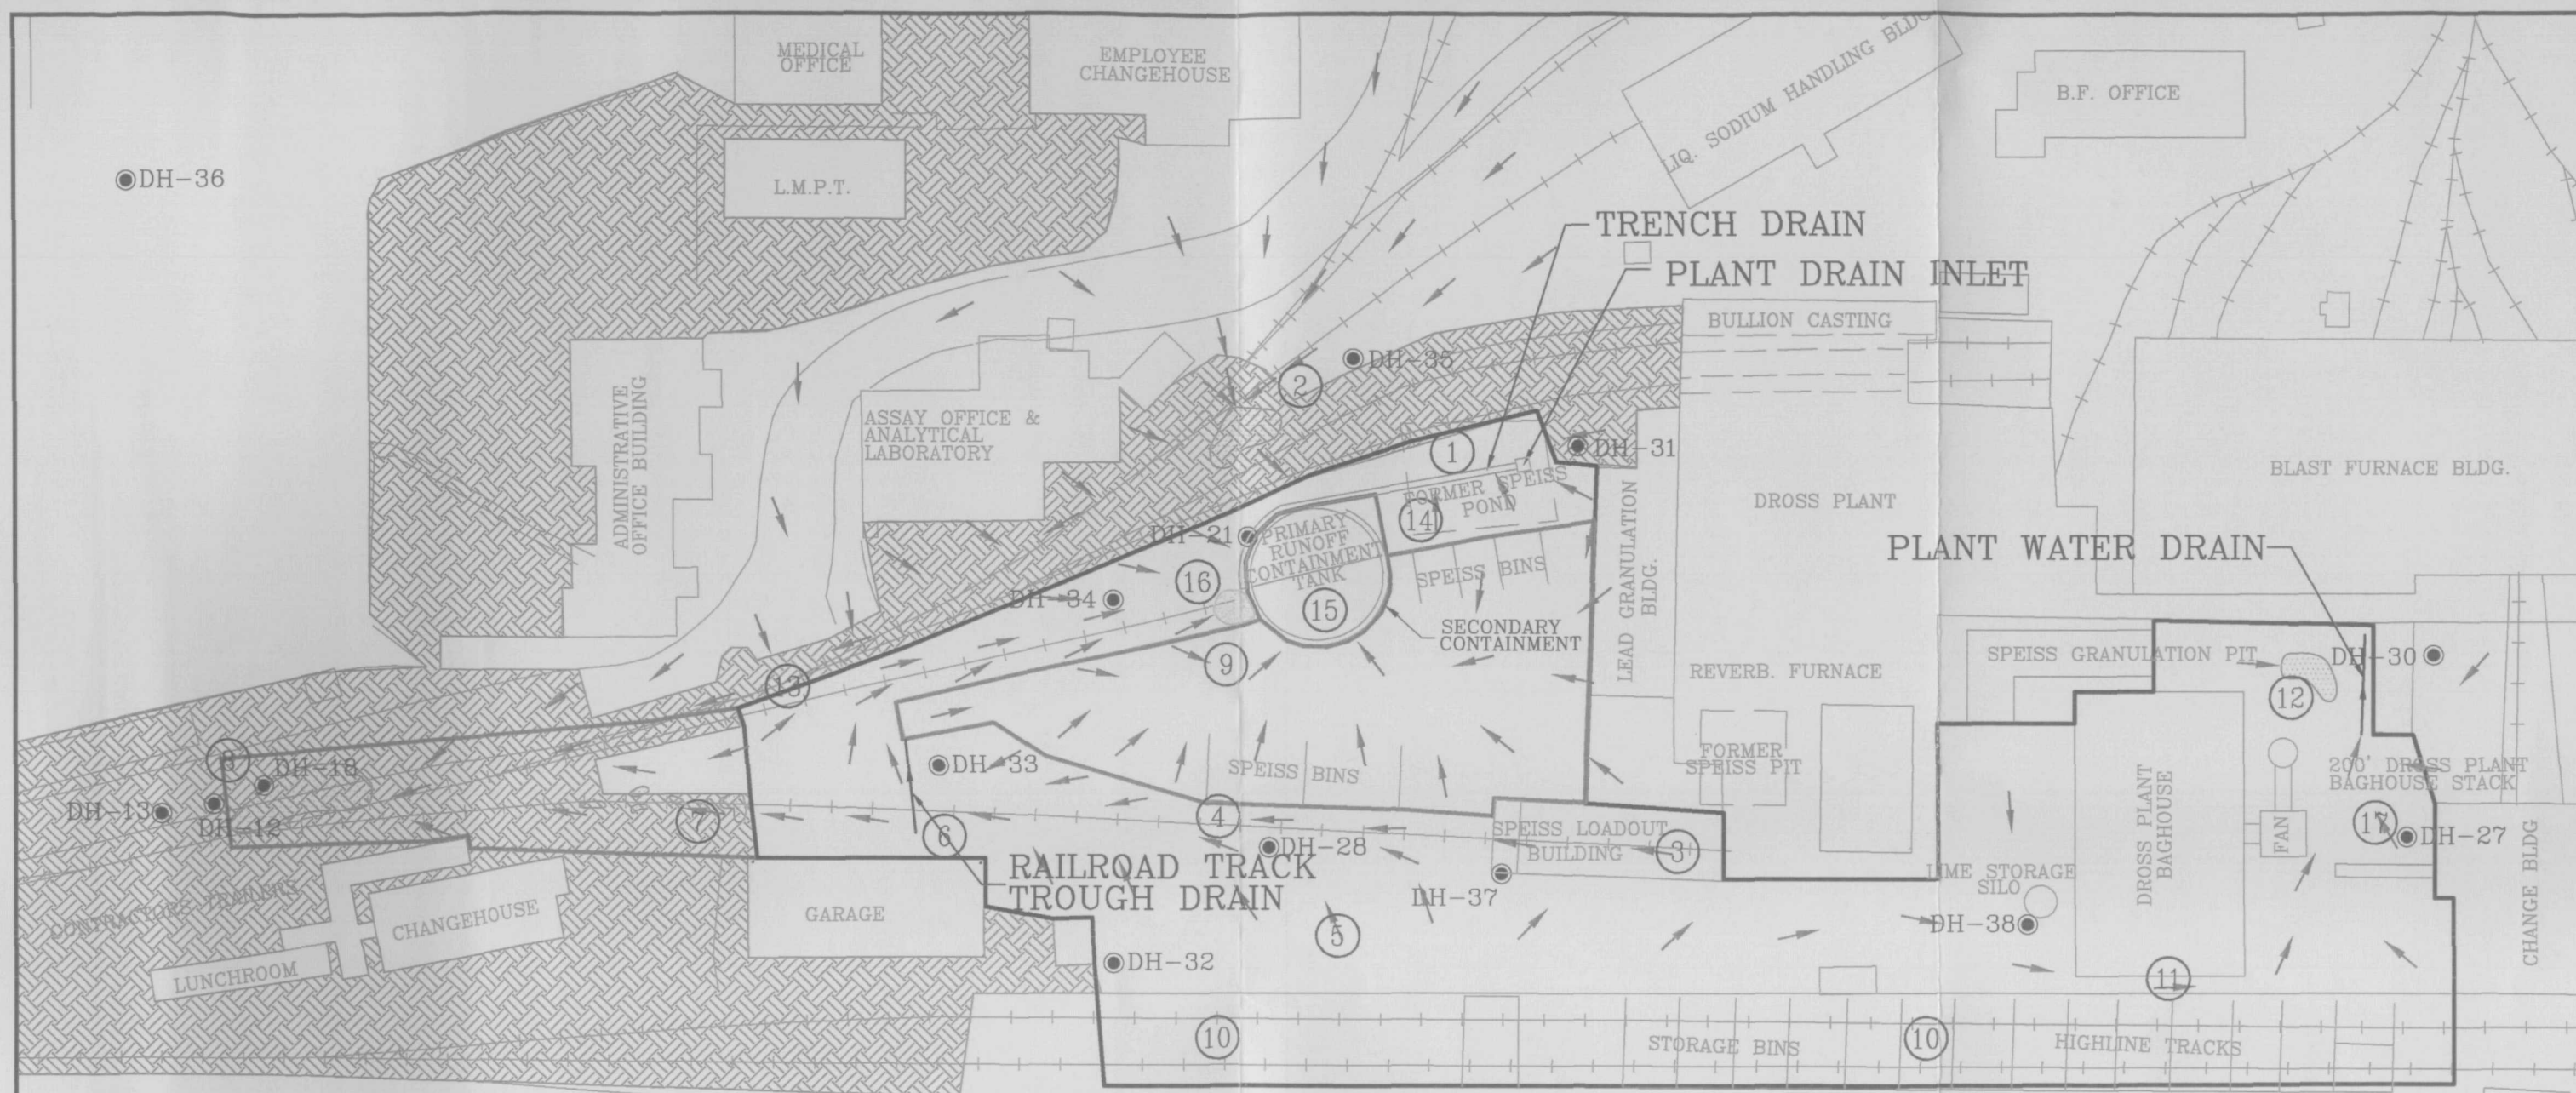
Figure 2-1 shows surface runoff patterns in the Speiss Handling Area and adjacent unpaved areas. As previously noted in Section 2.1, stockpiles of speiss are temporarily stored on an open concrete pad, which drains through runoff conveyance pipes to a runoff containment system that includes a primary tank placed within a concrete secondary containment unit (see Figure 2-1 and Exhibit 1). With the exception of a few areas described in the following section and noted in Figure 2-1, runoff in the central portion of the Speiss Handling Area appears to be well contained.

Several small ponded areas were also noted in the paved roadway areas and in storage bins that underlie highline tracks on the west boundary of the Speiss Handling Area (see locations 10, 11 & 12 in Figure 2-1). Ponding increases the potential for infiltration through cracks or defects that may be present in the concrete. Drainage improvements recommended in Section 4.0 address surface water runoff in the Speiss Handling Area.

The physical condition and integrity of surface paving and runoff conveyances were inspected in the Speiss Handling Area as part of this investigation. Areas where conditions indicate a potential for infiltration are shown in Figure 2-1. The concrete paving in this area is generally intact, but there are local areas where cracks and potholes are present (locations 5, 10 & 17 in Figure 2-1). The runoff conveyances in the Speiss Handling Area include runoff conveyance pipes to the primary containment tank, and two trench drains designed to capture speiss impacted runoff.

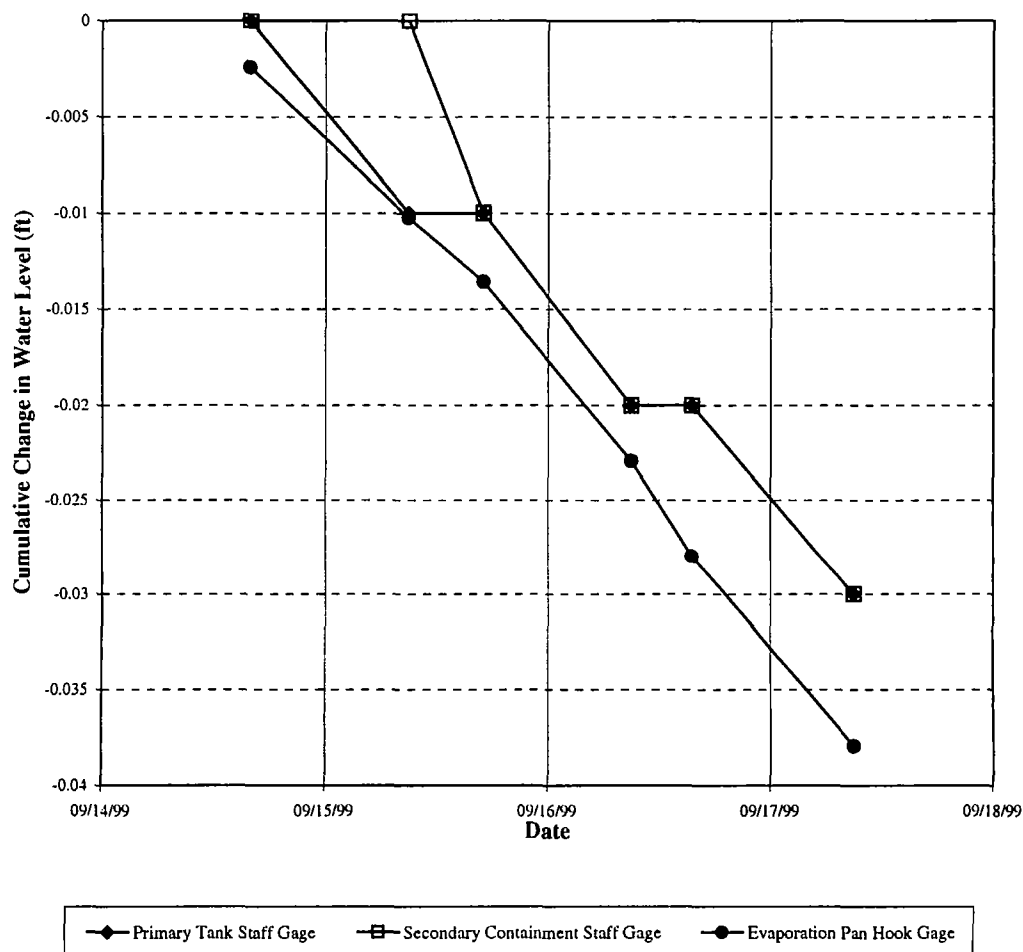
Figure 2-3. Speiss Handling Area Secondary Containment Test Results

No measurable precipitation was recorded during testing of the secondary containment, thus water loss through evaporation was the only variable affecting water levels (other than potential leakage). A total of seven manual water level measurements were collected over a period of four days (Figure 2-3). Although data logger readings were checked in the field and appeared to be consistent with manual readings, when the datalogger was downloaded it became apparent that the datalogger was not producing consistent readings. Further testing showed there were problems with the transducer that resulted in inaccurate readings, therefore the data logger results have not been included in the analysis of secondary containment water levels. Water level trends over the measurement period for the primary tank, the secondary containment, and the evaporation pan are shown on the graph in Figure 2-3.

The observed water level decreases in the primary tank and the secondary containment were virtually identical, and were equal to the observed water level decrease attributable to evaporation. Therefore, results for the secondary containment showed no evidence of detectable leakage to underlying soils and groundwater. At this point in the test, there remained some possibility of leakage if the water levels in the secondary tank were

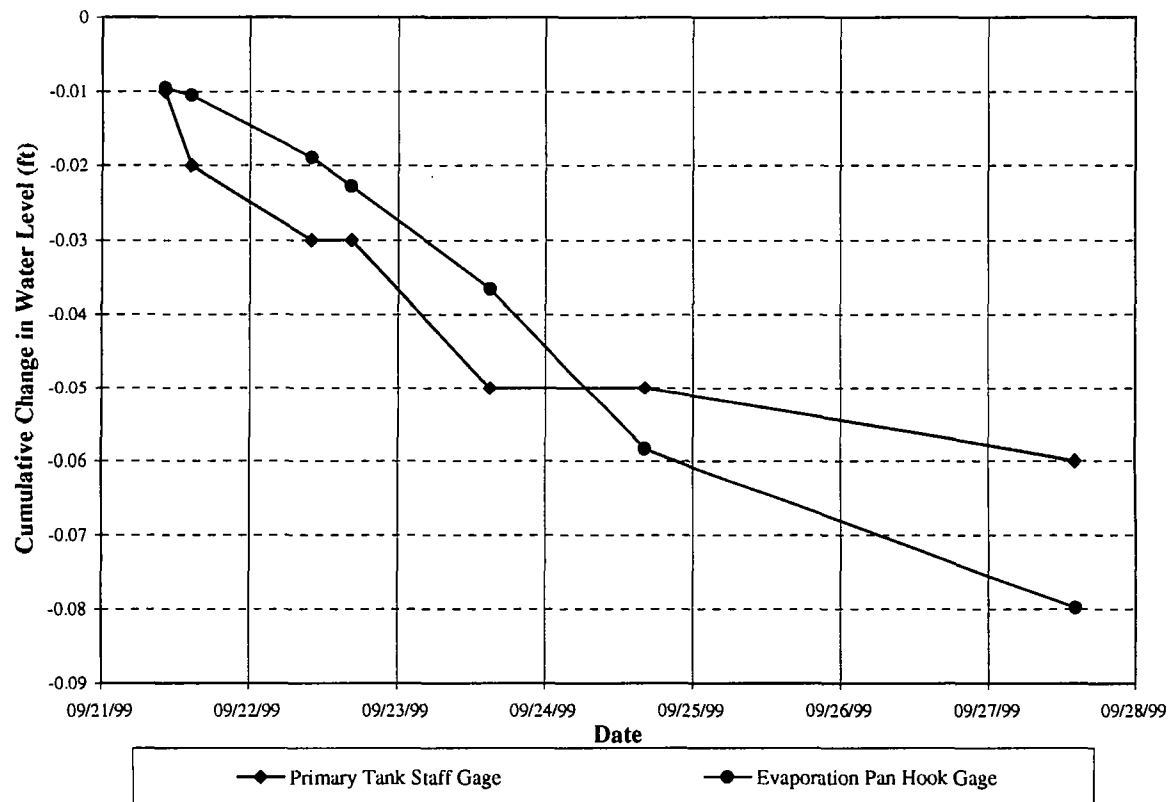
Figure 2-4. Speiss Handling Area Primary Tank Test Results

influenced by leakage from the primary containment tank. However, as described in the following section, subsequent testing of the primary containment with a tracer confirmed that the primary tank is not leaking. There are still limitations on the minimum leakage rate that would be observable under the conditions of the test. Volume calculations based on the dimensions of the secondary containment indicate 0.01 feet of water level change is equal to approximately 15 gallons. The observed water loss due to evaporation was, therefore, about 15 gallons per day from the secondary containment or about 0.01 gallons per minute. A leakage rate that was a small percentage of this evaporation rate (less than 0.001 gallons per minute, for example) would not be measurable under these conditions. Nevertheless, the correlation of water levels in the primary tank, the secondary containment, and the evaporation pan during this test, do not show any evidence of leakage from the secondary containment.

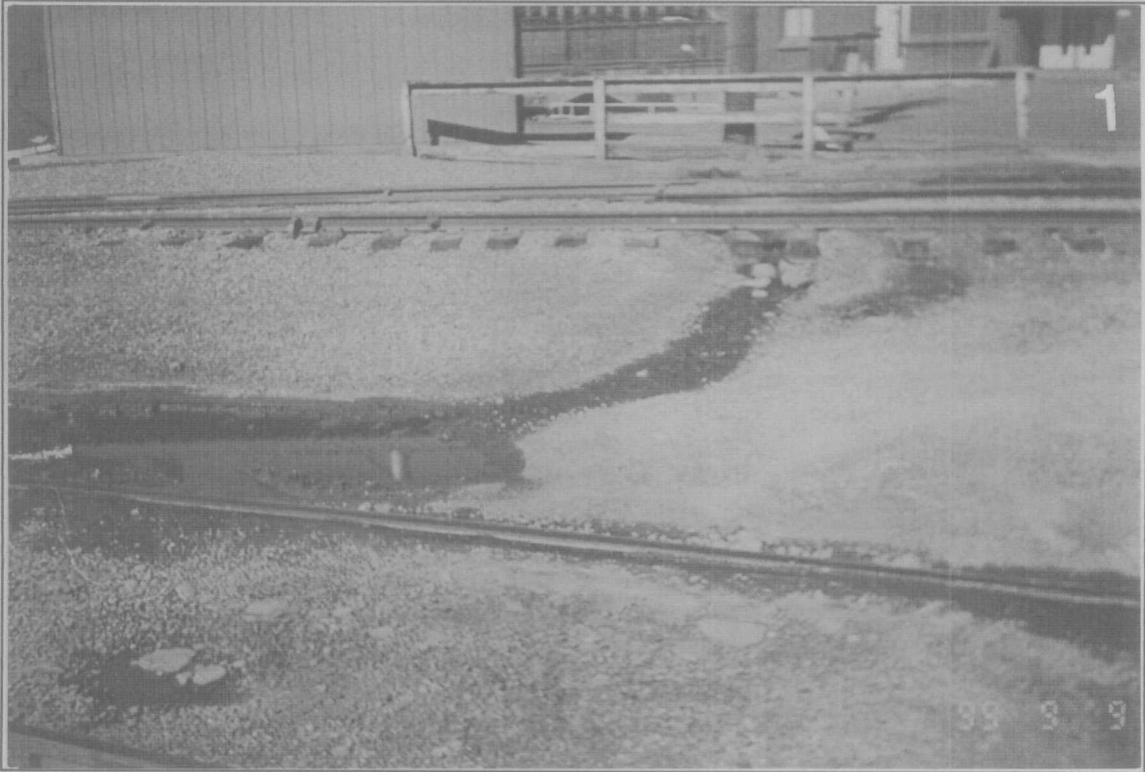
unpaved track area running along the eastside of the Speiss Handling Area also receives some runoff, primarily from the paved area to the east. There is one location in particular where runoff is channeled into this unpaved track area, and evidence of ponding and infiltration is present (see location 2 in Figure 2-1, and photo 1 in Appendix A).

Track Area Ponding
(see Figure 2-1, Number 2)

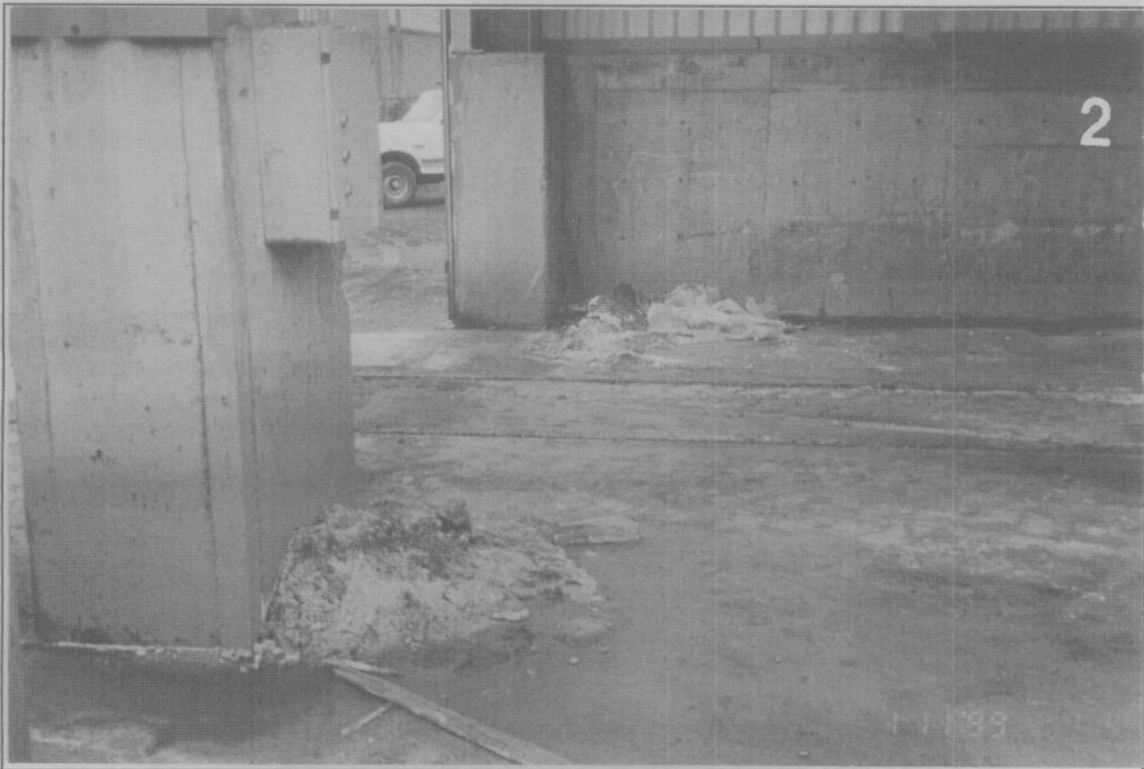
Speiss Loadout Facility Spillage
(see Figure 2-1, Number 3)

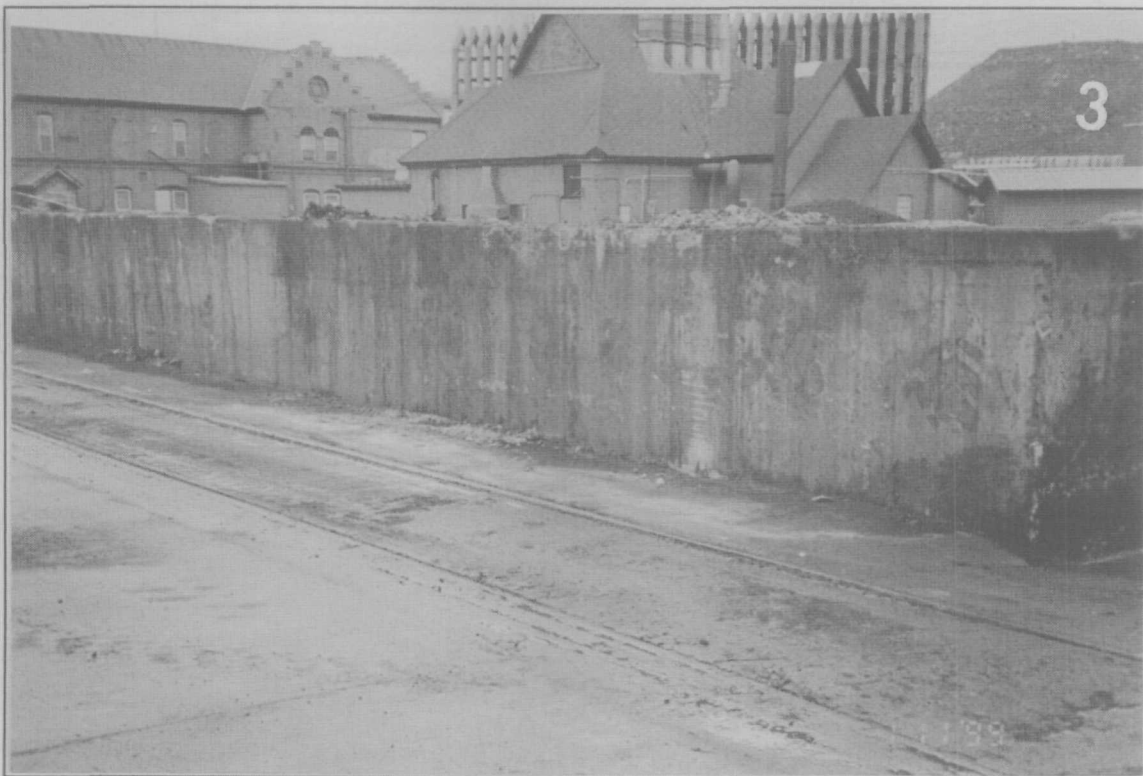
Speiss Bins (West) Spillage
(see Figure 2-1, Number 4)

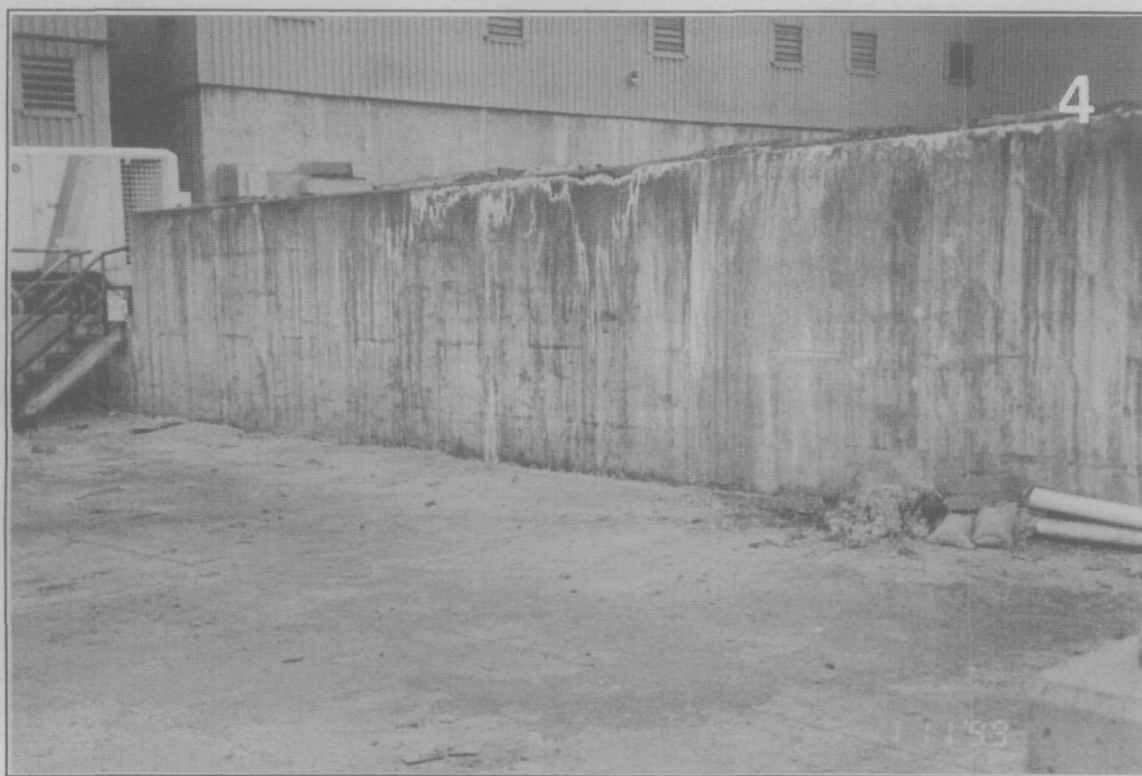
Speiss Bins (East) Spillage
(see Figure 2-1, Number 14)

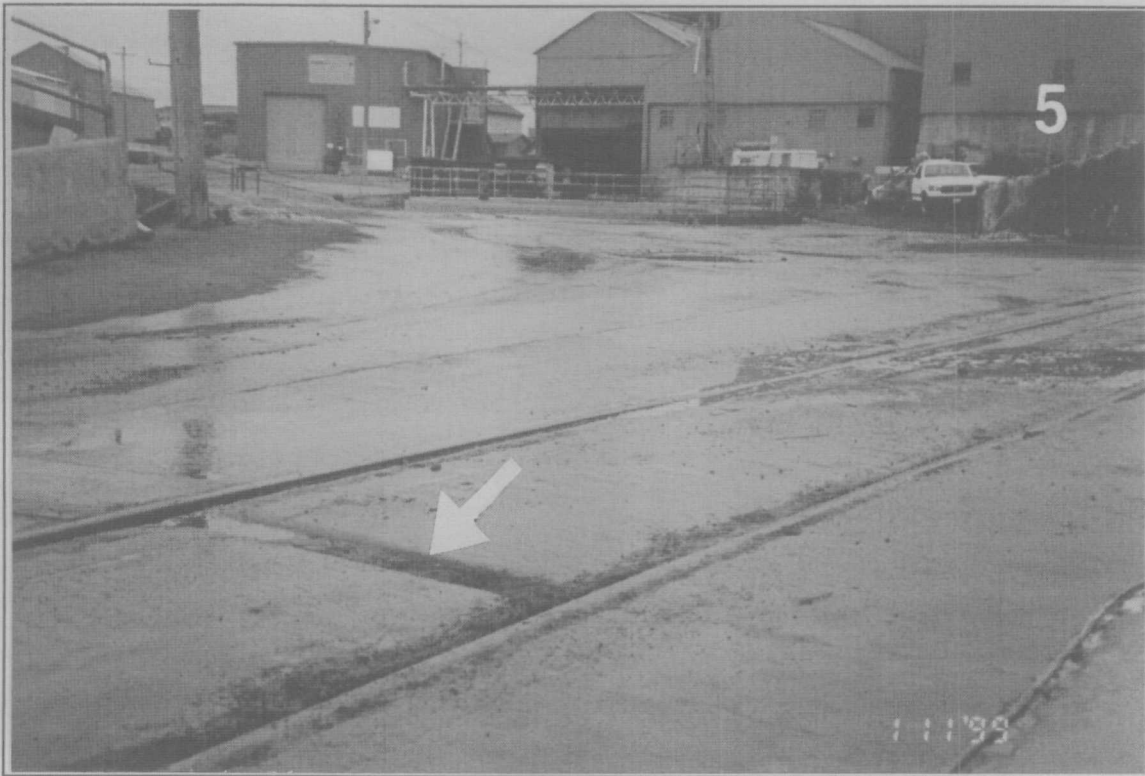
RR Track Drain Plugged
(see Figure 2-1, Number 6)

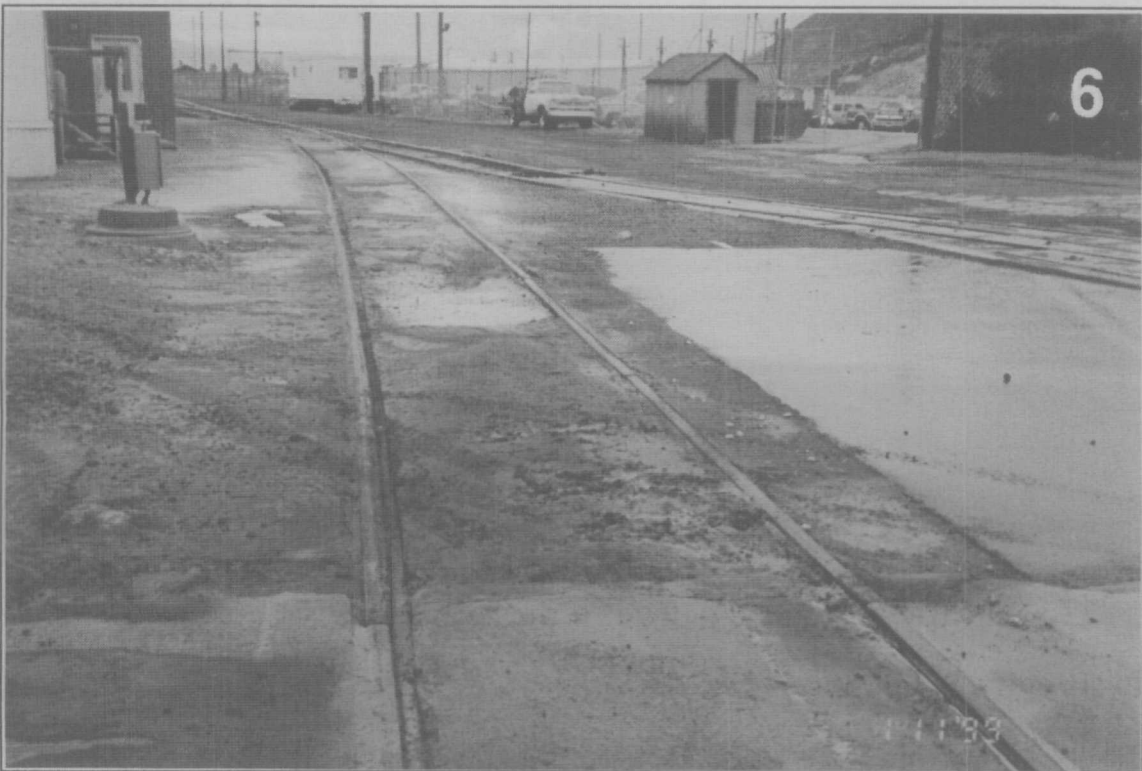
Paving Ends and Ponding Along RR Tracks
(see Figure 2-1, Number 7)

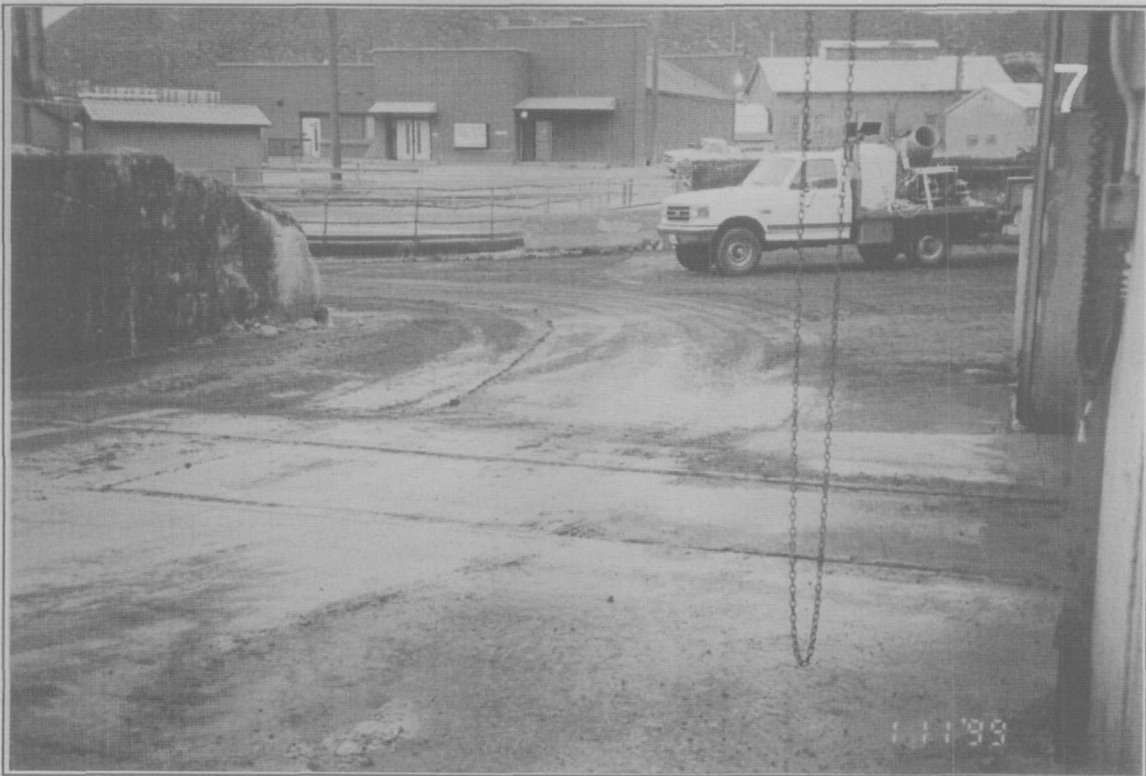
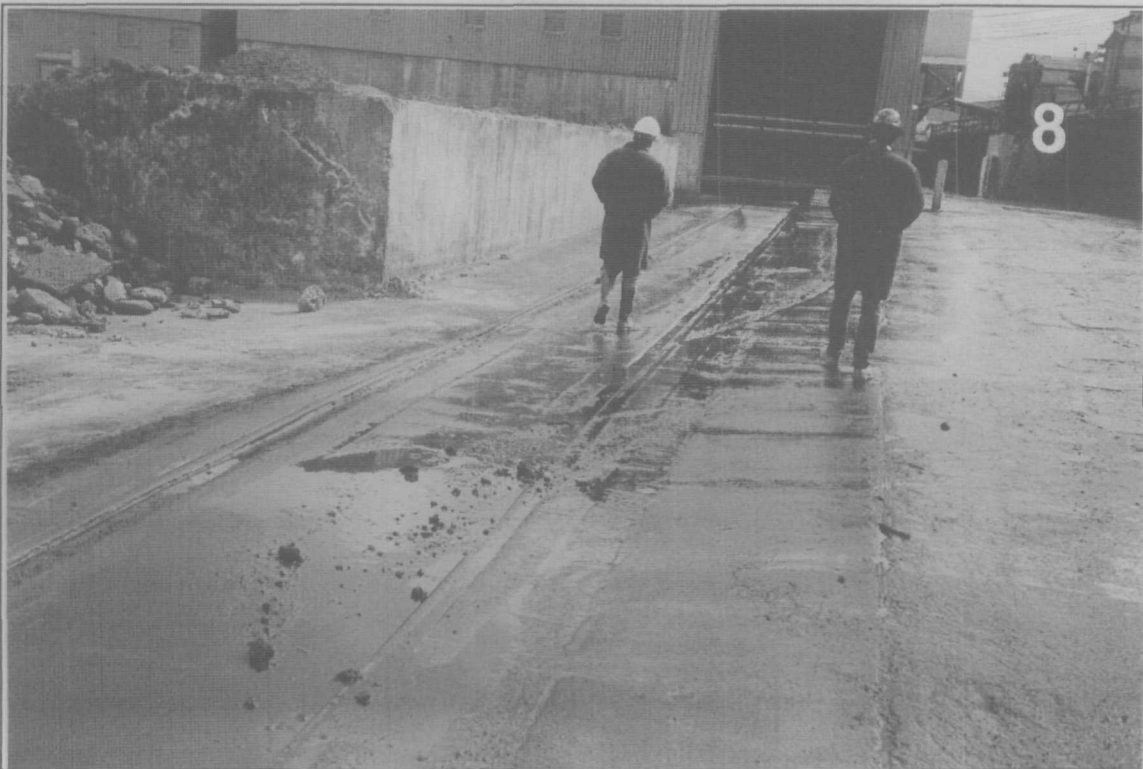
**Roadway Surface Condition and Water Truck Runoff Near West Speiss Bins
(see Figure 2-1, Number 5)**

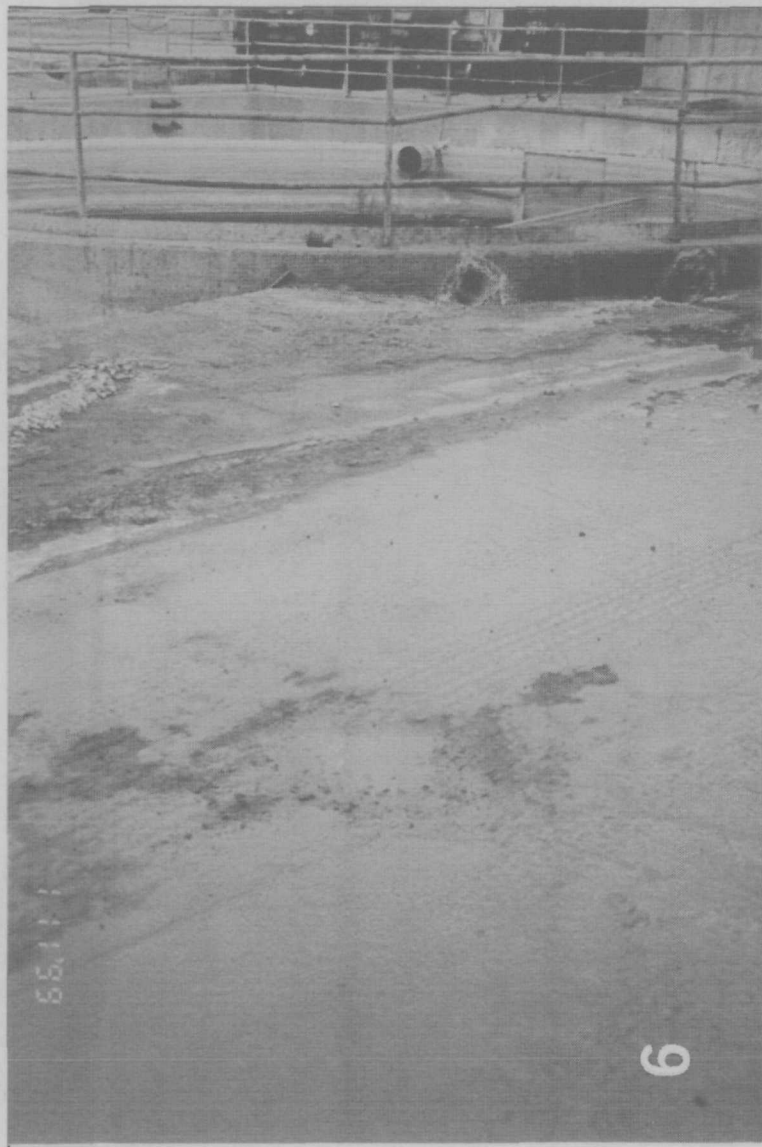
Pothole in Roadway (see Figure 2-1, Number 9)

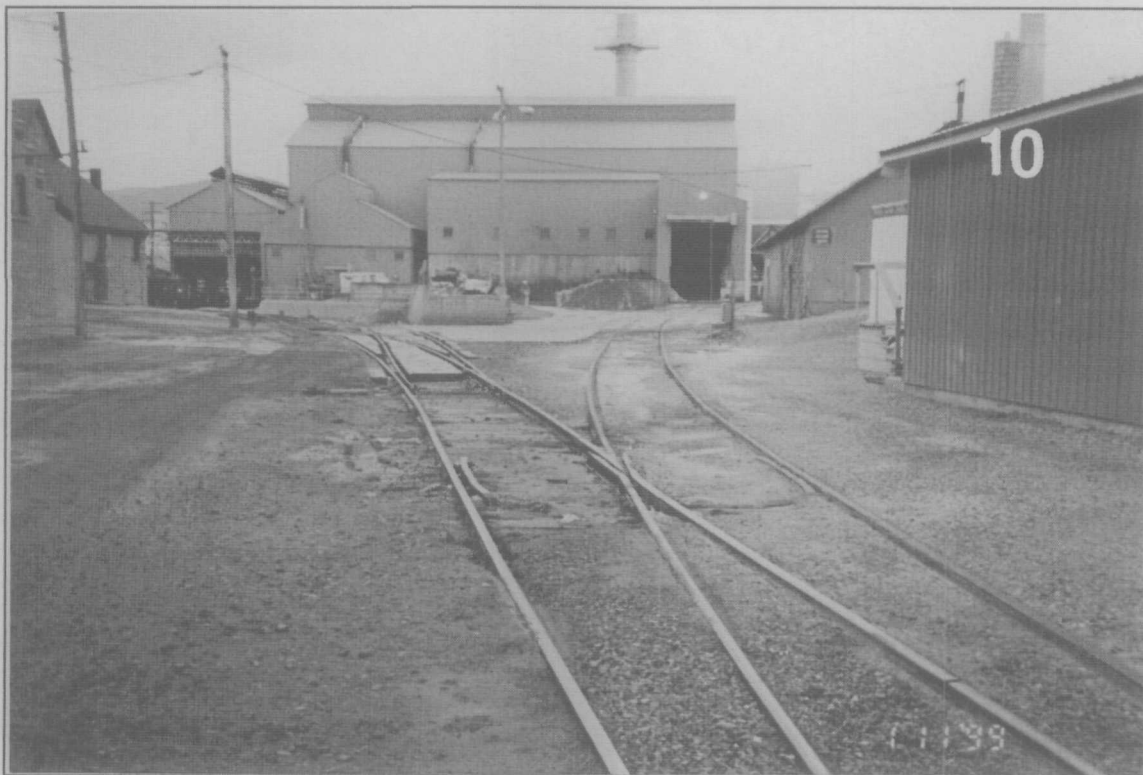
Ponding Along RR Tracks Near Wells DH-12, DH-13
(see Figure 2-1, Number 8)

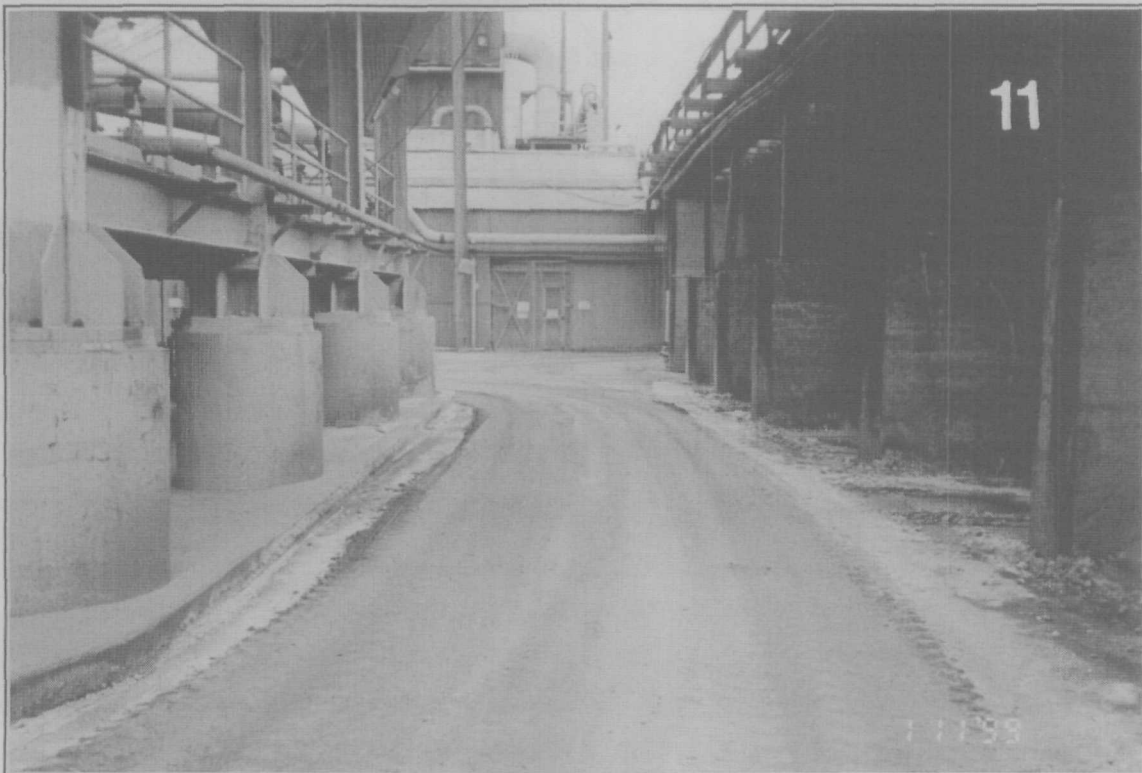
Ponded Areas in Roadway Around Dross Plant Baghouse
(see Figure 2-1, Number 11)

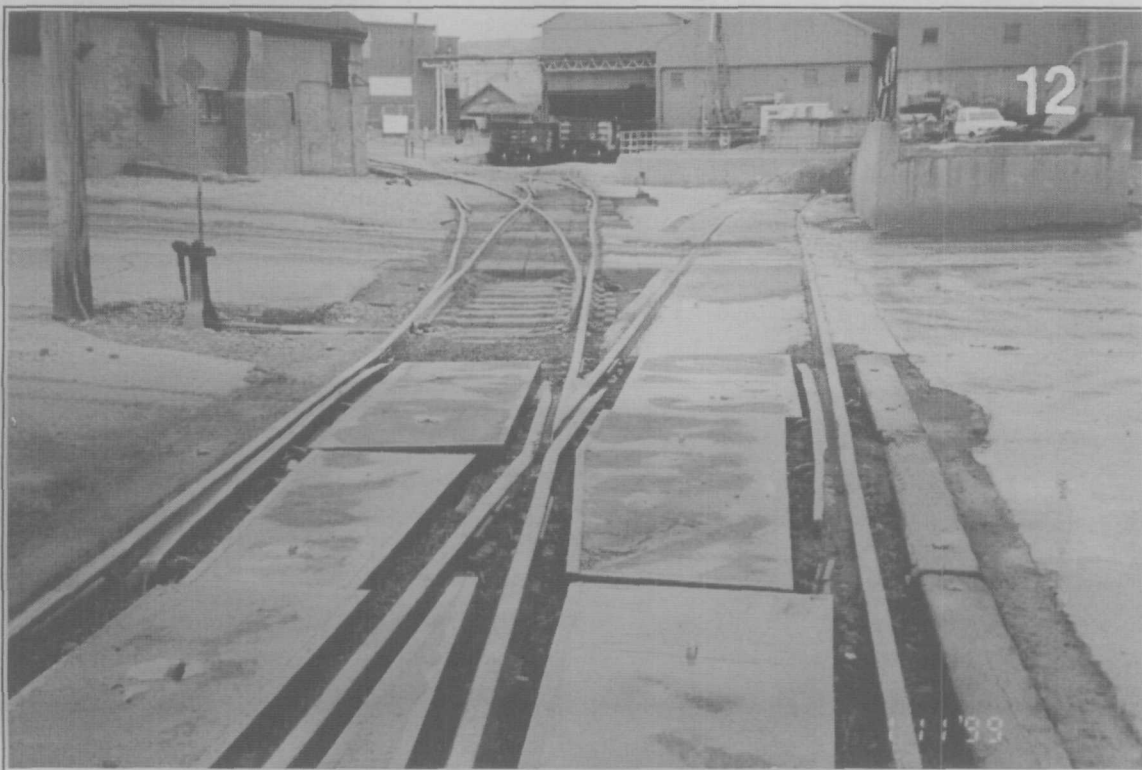
Runoff to Unpaved RR Track Crossing
(see Figure 2-1, Number 13)

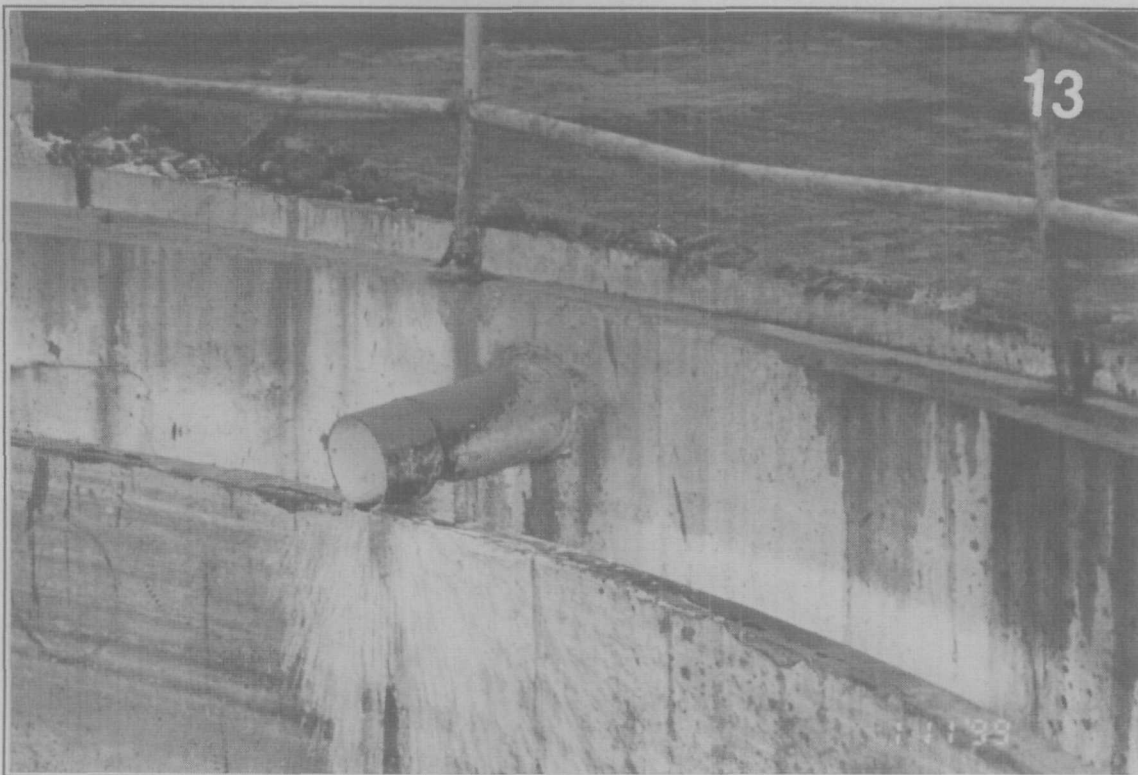
Examination of runoff conveyance pipes from the Speiss Handling Pad to the primary runoff containment tank shows that some leakage around the conveyance pipes to the secondary containment. The location of the runoff containment tanks and conveyance pipes are shown in Figure 2-1 (location 15). A plan showing the general conveyance pipe installation is shown in Appendix B and evidence of leakage around the pipes is shown in photo 13 in Appendix A.

Primary Speiss Tank Inlet Pipes Leaking to Secondary Containment
(see Figure 2-1, Number 15)

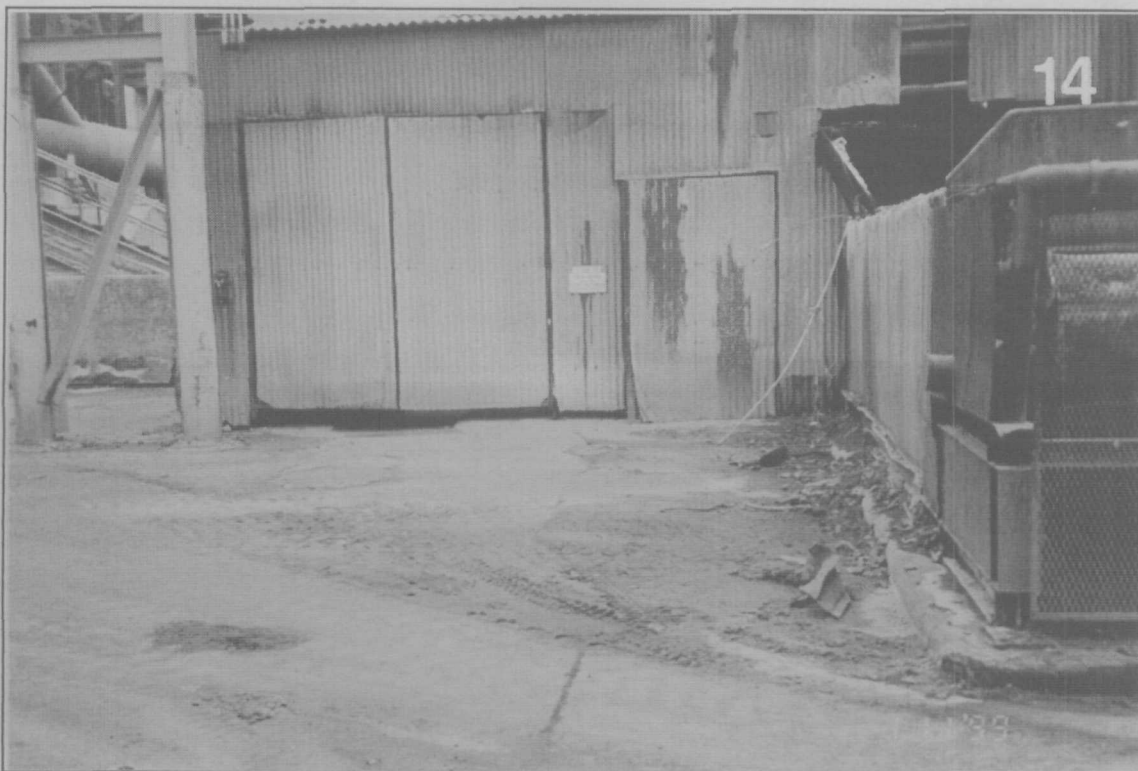
Broken Concrete at Charge Car Building Door
(see Figure 2-1, Number 17)

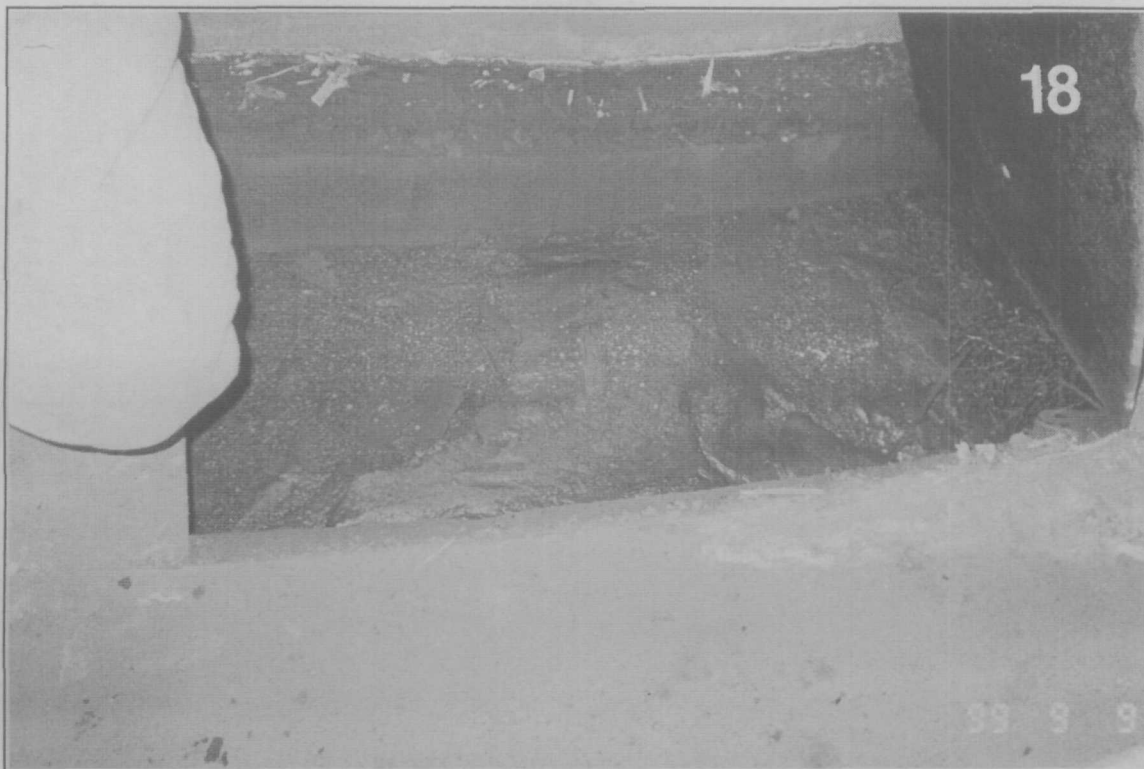
A second larger trench drain is located below (east of) the speiss runoff containment tank and was also filled with sediment during the drain inspection (see location 1 in Figure 2-1, and photo 18). One source of sediment to this drain was a sand pile rail car stop located near the north end of the trench drain (see location 16 in Figure 2-1 and photo 20). Cracks were noted in the concrete walls and concrete bottom of the drain, which may result in seepage to groundwater. This trench drain was tested for leaks, and test procedures and results are discussed in Section 2.3 of this report.

Sediment Accumulation in Trench Drain Prior to Cleaning
(see Figure 2-1, Number 1)

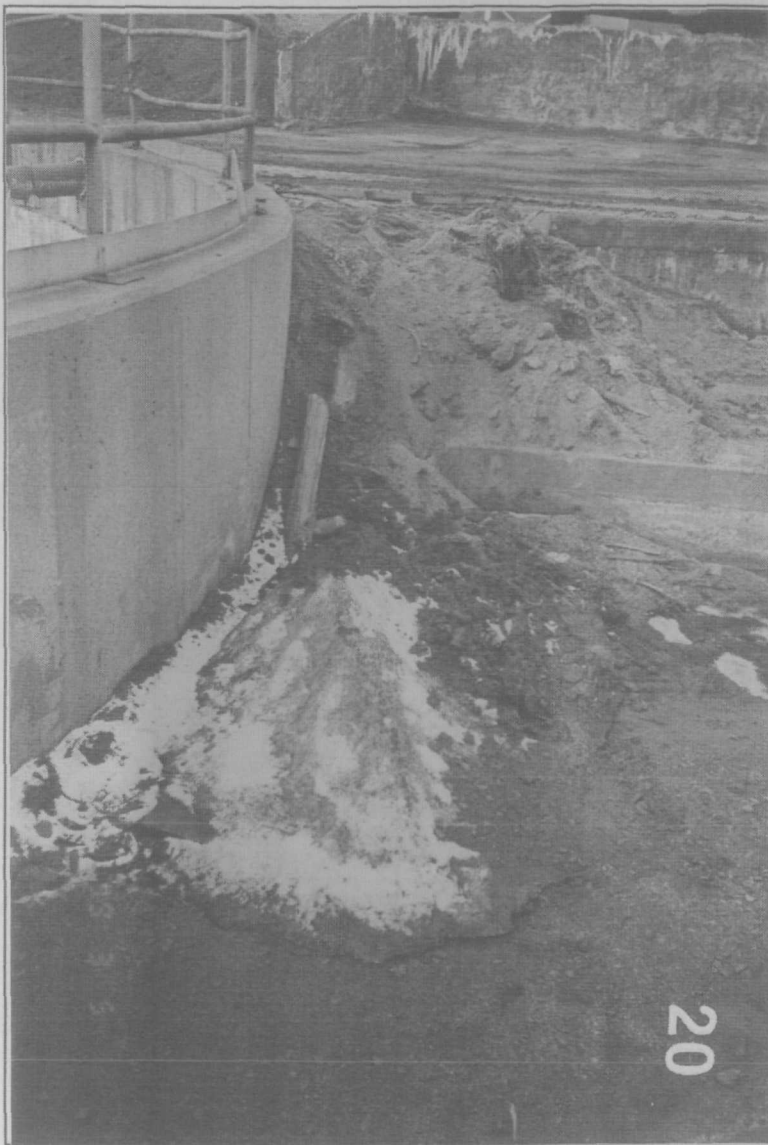
Sand Pile Covering Trench Drain at Upstream End
(see Figure 2-1, Number 16)

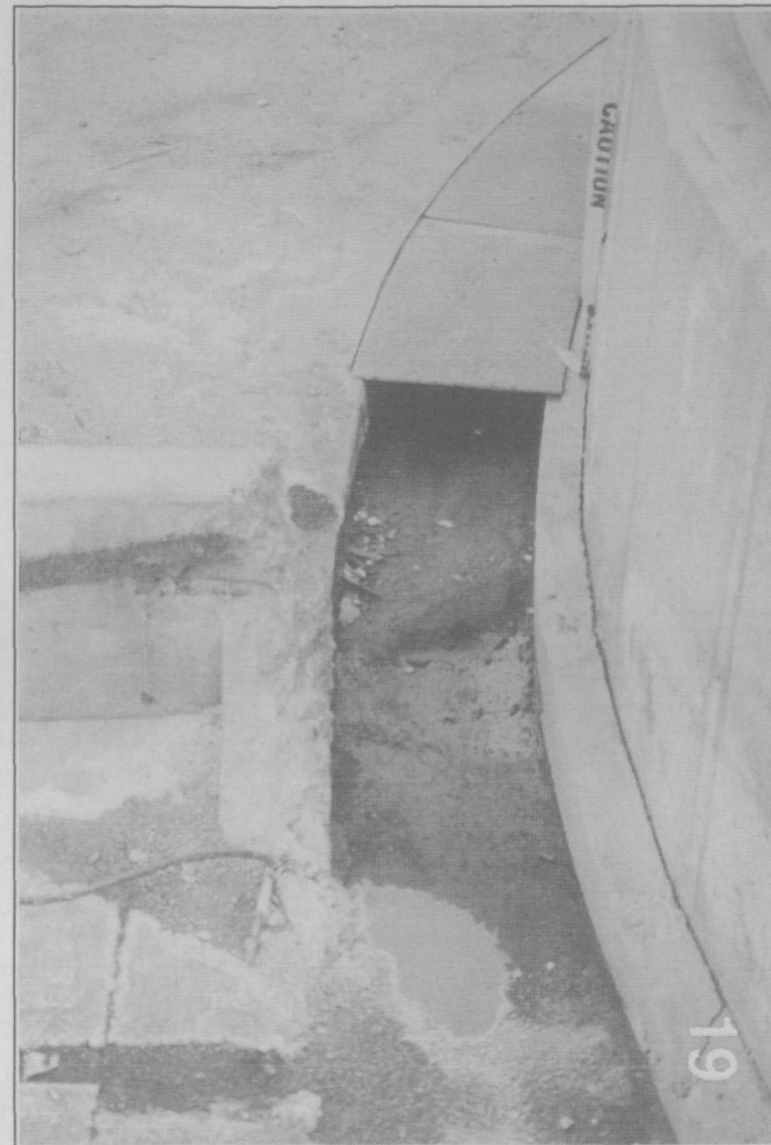
Trench Drain at Upstream End After Removal of Sand Pile
(note cracks at base of speiss tank and in trench wall)
(see Figure 2-1, Number 16)

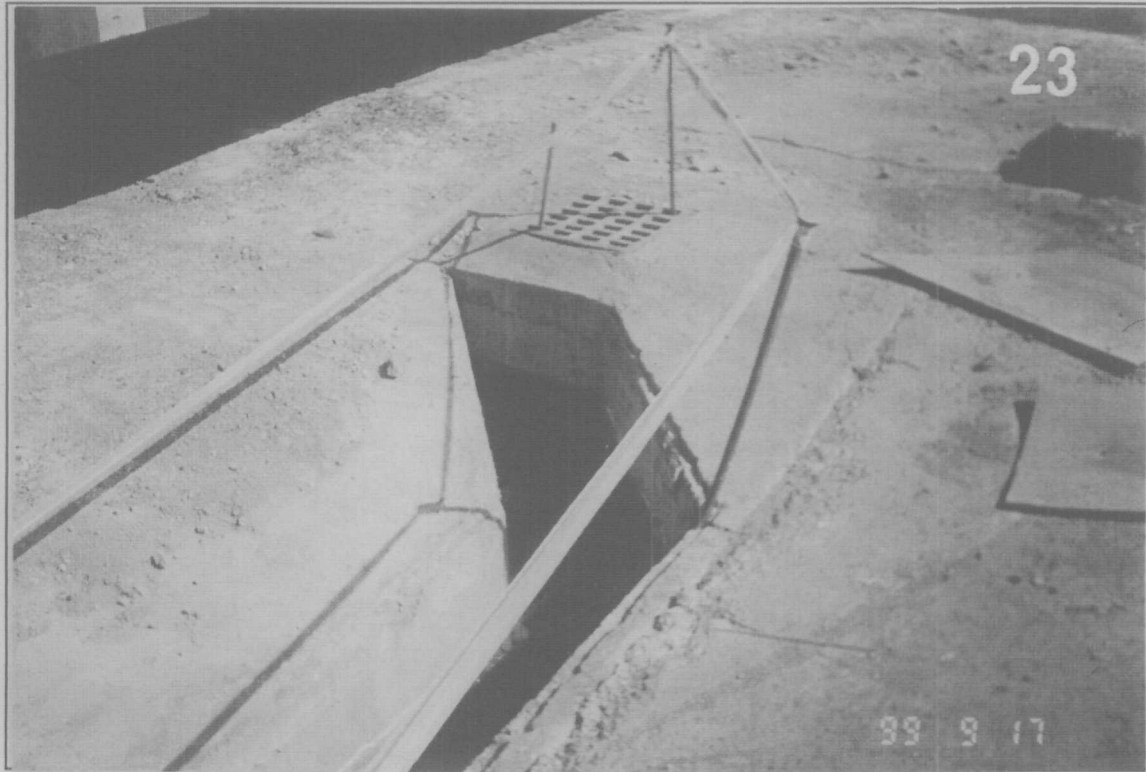
**Sediment and Ponded Water in Trench Drain at Plant Drain Inlet
(see Figure 2-1, Number 1)**
